## Test Report

No.: SHAEC26028232507

Sample Name: PA6

### Halogen

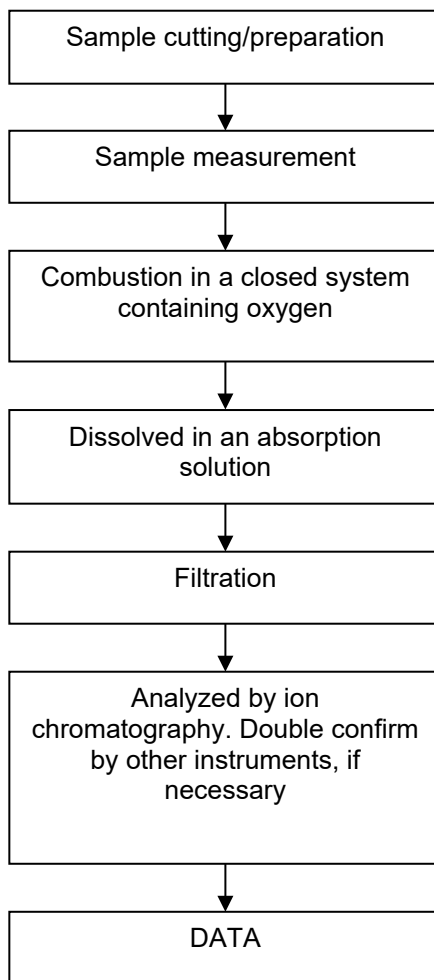
#### Halogen Testing Flow Chart

**Test Method:** With reference to EN 14582:2016, analysis was performed by IC.

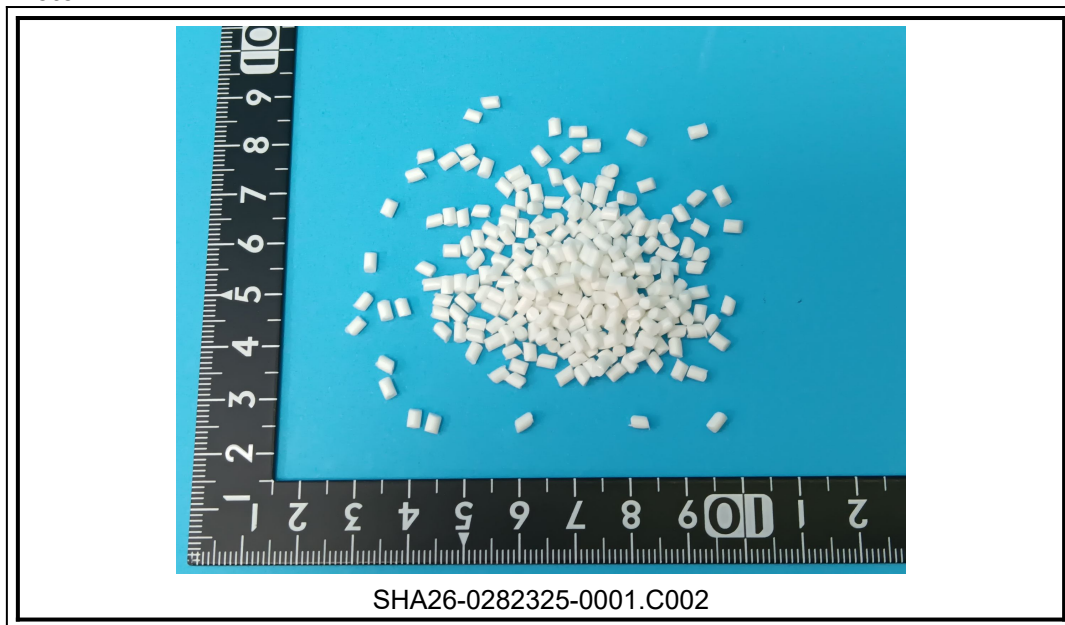
Sample Photo:

| SN ID | Sample No. | SGS Sample ID | Description |
|---|---|---|---|
| SN1 | A2 | SHA26-0282325-0001.C002 | White solid pellet |
